STRESS WAVE RESPONSE OF CARBON
COMPOSITE MATERIALS

Floyd R. Tuler, et al

Effects Technology, Incorporated

January 1974

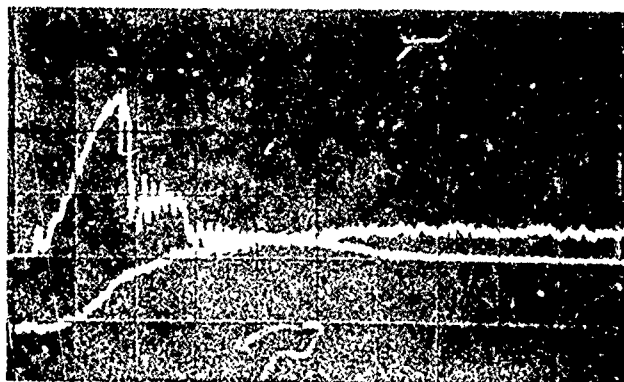
SPECIMEN 6M2
LOAD: 50 lb/div
ENERGY: 0.267 ft-lb/div
TIME: 0.5 msec/div

SPECIMEN 2550-3
LOAD: 50 lb/div
ENERGY: 0.267 ft-lb/div
TIME: 0.5 msec/div

SPECIMEN 2931-2
LOAD: 50 lb/div
ENERGY: 0.267 ft-lb/div
TIME: 0.5 msec/div

Figure 3.27. Oscilloscope Traces from Fracture Tests on 3D Carbon Phenolic Composite M2 Virgin and Compressive Wave Damage Specimens. (Arranged in Order of Increasing Impulse.)

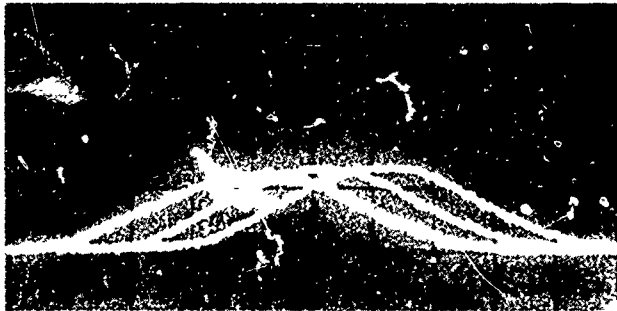
SPECIMEN 2531-1

UPPER TRACE: LOAD
50 lb/div
LOWER TRACE: ENERGY
0.267 ft-lb/div
TIME: 1 msec/div

LOAD: 20 lb/div
TIME: 5 msec/div

Figure 3.29. Oscilloscope Traces from Fracture and Compliance Tests on 3D Carbon Phenolic Composite M1 Tensile Wave Damage Specimens.

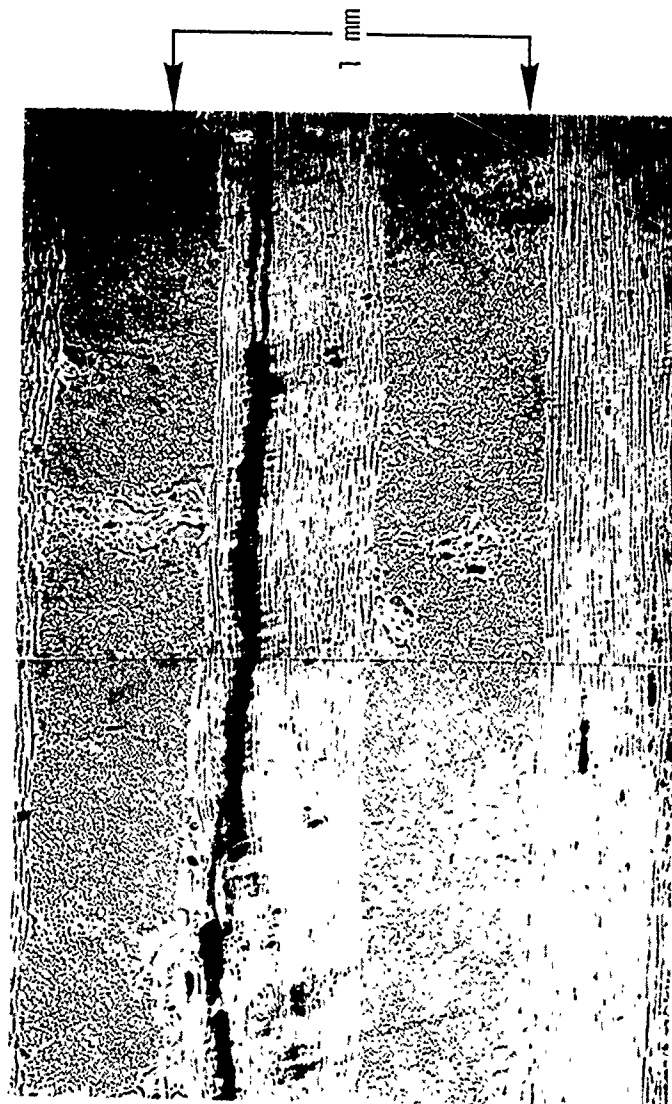
Figure 4.22. Photomicrograph of Sectioned Tensile Wave Damage Shot 3686;
 2D Carbon Carbon Impacted at 0.0083 cm/us with 0.076 cm Thick
 Plexiglas Flyer.

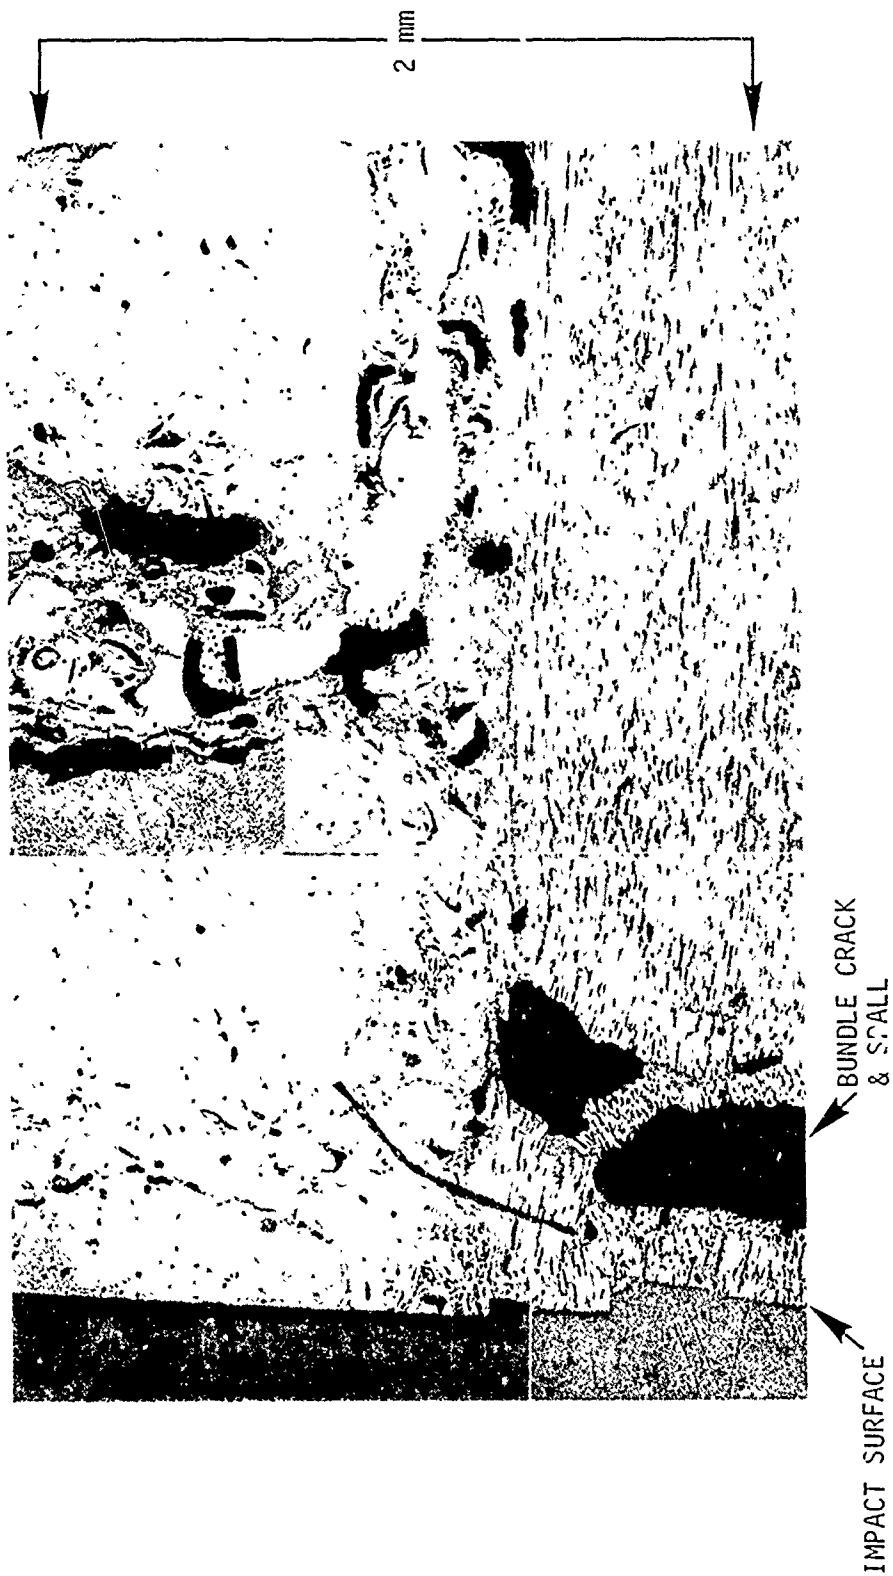
Figure 4.35. Photomicrograph of Sectioned Tensile Wave Damage Shot 3581;
3D Carbon Carbon Impacted at 0.0175 cm/ μ sec with 0.152 cm Thick
Plexiglas Flyer.

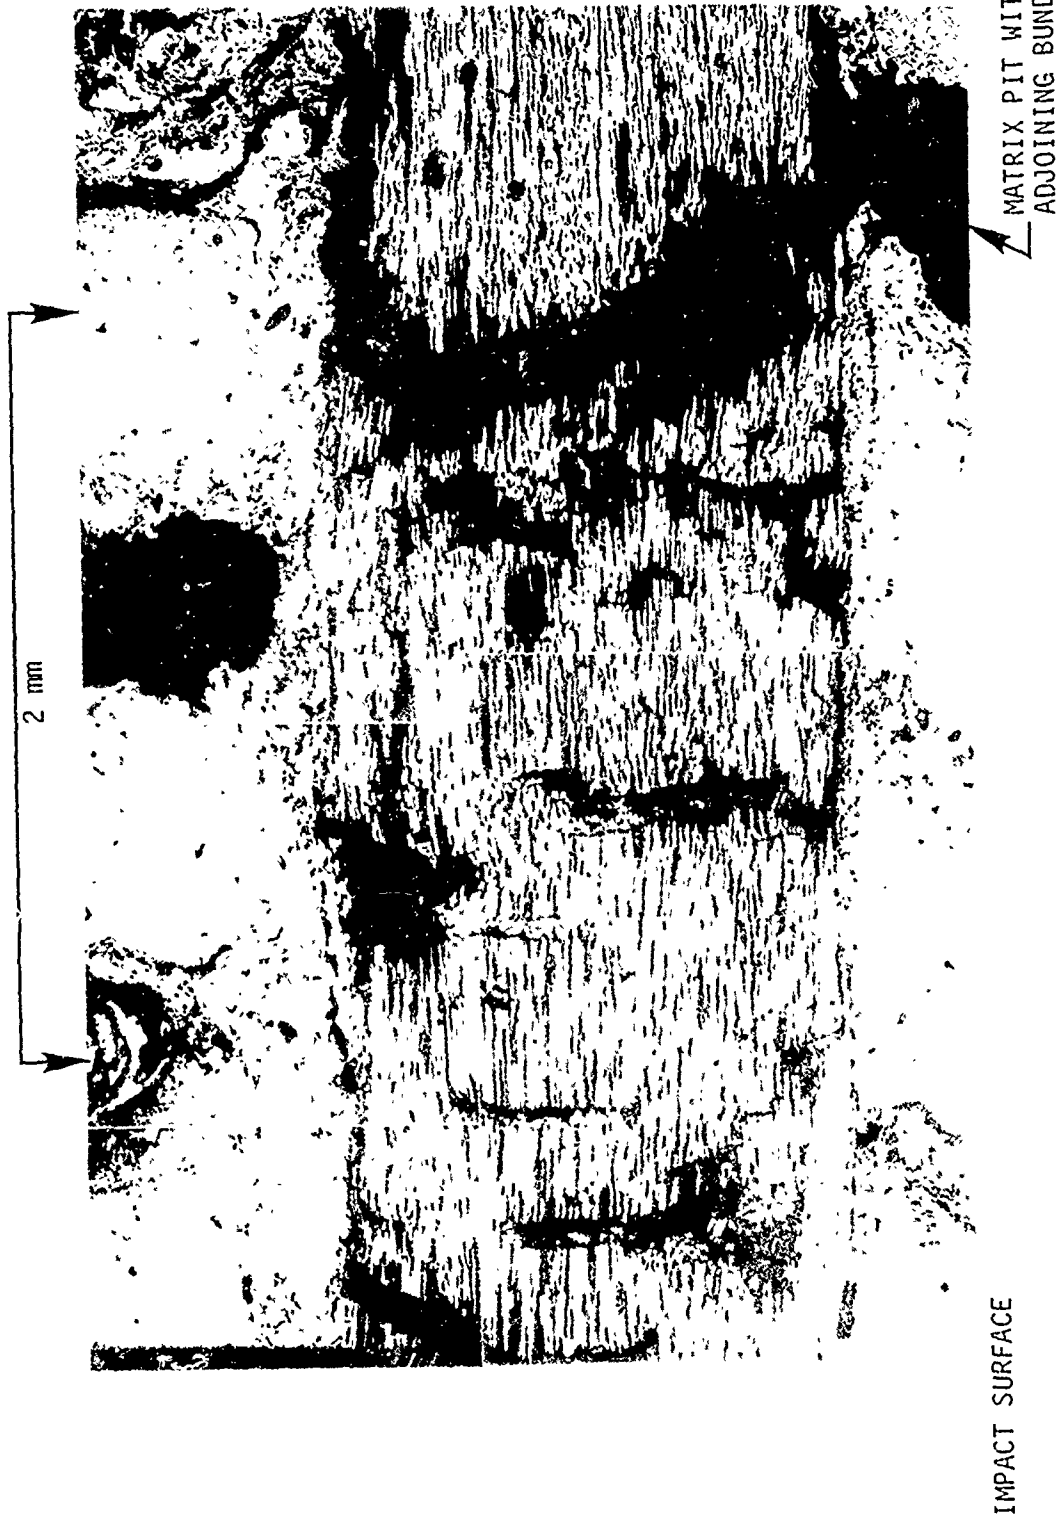
Figure 4.37 . Photomicrograph of Sectioned Tensile Wave Damage Shot 3572;
3D Carbon Carbon Impacted at 0.049 cm/ μ sec with 0.152 cm Thick
Plexiglas Flyer.

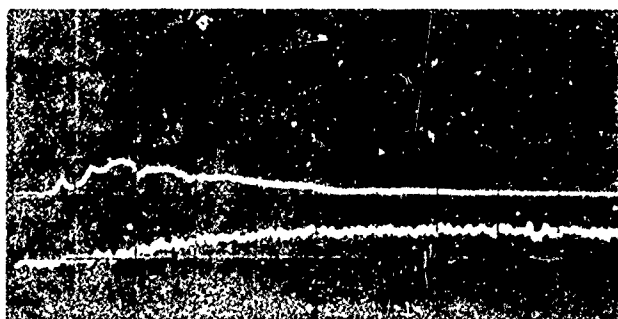
SPECIMEN 3692-3
LOAD: 50 lb/div
ENERGY: 0.267 ft-lb/div
TIME: 0.5 msec/div

SPECIMEN 3694-1
LOAD: 50 lb/div
ENERGY: 0.267 ft-lb/div
TIME: 0.5 msec/div

Figure 4.44. Oscilloscope Traces from Fracture Tests on 3D Carbon Carbon Virgin and Compressive Wave Damage Specimens (Arranged in Order of Increasing Impulse).

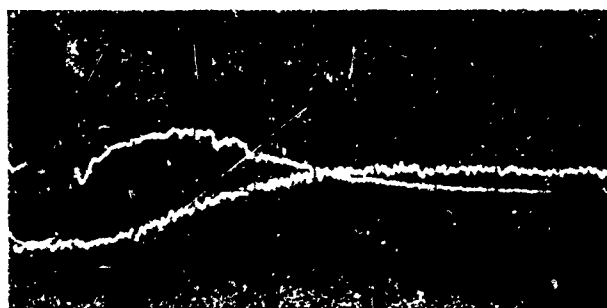
SPECIMEN 3572-2
LOAD: 50 lb/div
ENERGY: 0.267 ft-lb/div
TIME: 0.5 msec/div

SPECIMEN 3547-3
LOAD: 50 lb/div
ENERGY: 0.267 ft-lb/div
TIME: 0.5 msec/div

Figure 4.45. Oscilloscope Traces from Fracture Tests on 3D Carbon Carbon Virgin and Tensile Wave Damage Specimens (Arranged in Order of Increasing Impulse).
